DEPARTMENT OF TRANSPORTATION

Quality Assurance and Source Inspection

Contract #: 04-0120F4Cty: SF/ALA Rte: 80 PM: 13.2/13.9File #: 1.28**WELDING INSPECTION REPORT****Resident Engineer:**Siegenthaler, Peter**Address:** 333 Burma Road**City:** Oakland, CA 94607**Report No:** WIR-026055**Date Inspected:** 13-Aug-2011**Project Name:** SAS Superstructure**OSM Arrival Time:** 700**Prime Contractor:** American Bridge/Fluor Enterprises, a JV**OSM Departure Time:** 1530**Contractor:** American Bridge/Fluor Enterprises, a JV**Location:** Job Site

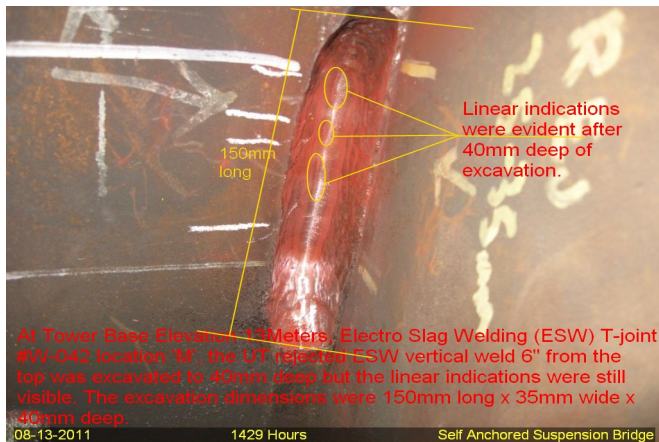
At Tower Base Elevation 13Meters, Electro Slag Welding (ESW) T-joint N-045 location 'E', QA randomly ABF welder Jorge Lopez perform 3G SMAW second time welding repair (R2) on the Ultrasonic Testing (UT) detected defect on the vertical weld of the ESW. The welder was observed welding in the 3G (vertical) position utilizing Shielded Metal Arc Welding (SMAW) with 1/8" diameter E7018H4R electrode implementing welding procedure

At Tower Base Elevation 13Meters, Electro Slag Welding (ESW) T-joint #N-045 location 'E', ABF welder Jorge Lopez was noted preheating the excavation and adjacent base metal to more than 300 degrees Fahrenheit prior the 2nd time welding repair.

ABF-WPS-D15-1000-Repairs. The boat shape repair was excavated on the other side of the joint and was having dimensions of 100mm long x 30mm wide x 25mm deep. The repair excavation and the adjacent base metal was preheated to more than 300°F using propylene gas torch prior welding. During the shift, ABF QC Pat Swain was noted monitoring the welder. Measured welding parameter during welding was 125 amperes on a 1/8" diameter E7018H4R electrode. At the end of the shift, 3G repair welding was completed including grinding/cleaning of the weld cover.
